## Docket No. 217 - Development and Management Plan Inspection

Northeast Utilities Service Company Certificate of Environmental Compatibility and Public Need for the construction of a 345-kV electric transmission line and reconstruction of an existing 115-kV electric transmission line between Connecticut Light and Power Company's Plumtree Substation in Bethel, through the towns of Redding, Weston, and Wilton, and to the Norwalk Substation in Norwalk, Connecticut.

| Date: | September 10, 2004 |
| Location: | Norwalk Substation Expansion |

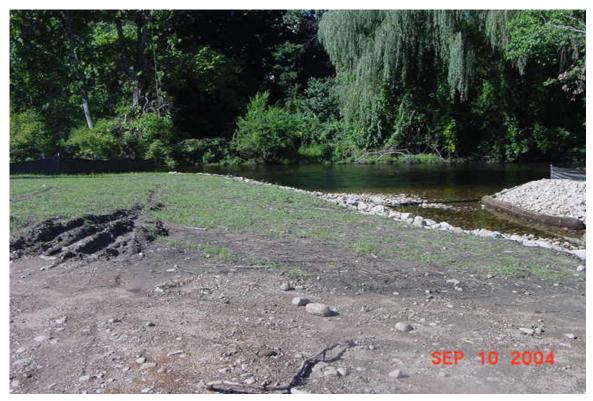
| Areas of Inspection | Observation | Recommended Action |
|--|--|--|
| | -Some areas adjacent to the overflow channel still have fairly sparse vegetative cover. 8/12-9/10//04 | -Getting seed and cover to establish here will be important before the growing season is over. The contractors are waiting to do final stabilization here once all adjacent work is complete. 8/26-9/10/04 |

View of the southern end of the overflow channel. Vegetation is still fairly sparse here and the overflow channel held water following the storm. 9/10/04

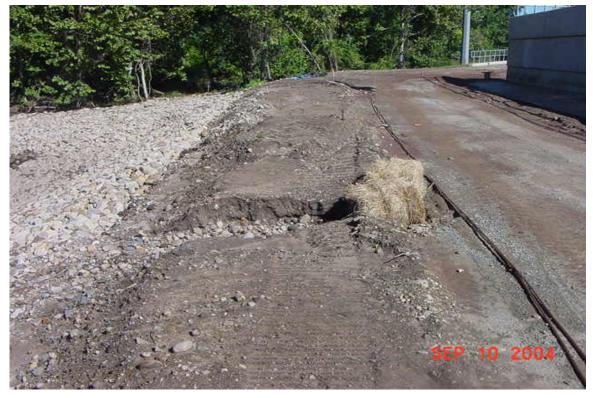
| Areas of Inspection | Observation | Recommended Action |
|---|--|---|
| | -The overflow channel held a large amount of water directly following the storm and still had flow within the meandering channel during the inspection. 9/10/04 - An eroded gully had occurred in the bank of the channel as a result of the rain. A haybale check dam was installed. 9/10/04 - Some additional erosion had occurred along the eastern side of the channel. A berm was removed and the area graded to created more sheet flow. | - The gully should be repaired and vegetative cover should be established on the area adjacent to the channel as soon as possible to help minimize erosion. 9/10/04 |

View of gully erosion at the edge of the overflow channel. A haybale check dam was installed but vegetative cover should be established as soon as possible. 9/10/04

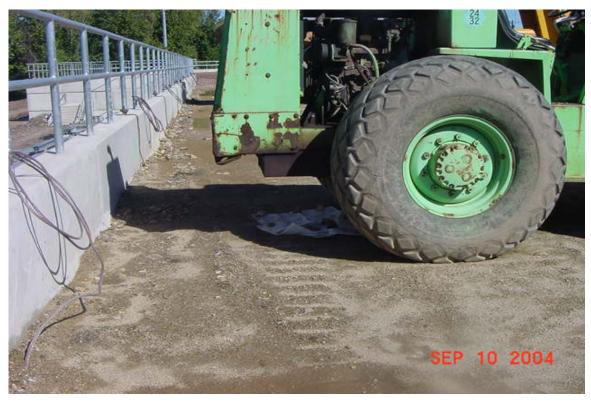
| Areas of Inspection | Observation | Recommended Action |
|---|--|---|
| Spills | - There were no spills reported during the week. Several diapers were noted under stationary equipment to prevent any potential drips. 9/10/04 - A small fuel leak was noted on a piece of rental equipment and it was attended to immediately. 9/10/04 | - The contractors should remain vigilant about securing and handling fuel containers due to the sensitivity of the area - Continue to keep all vehicles maintained well (i.e. no apparent fluid leaks) if they will be used or stored on site. Check equipment status on a regular basis. - Report spills to the office immediately, even if they are being controlled. |

Diapers were placed under several of the stationary pieces of equipment to control any potential drips. 9/10/04

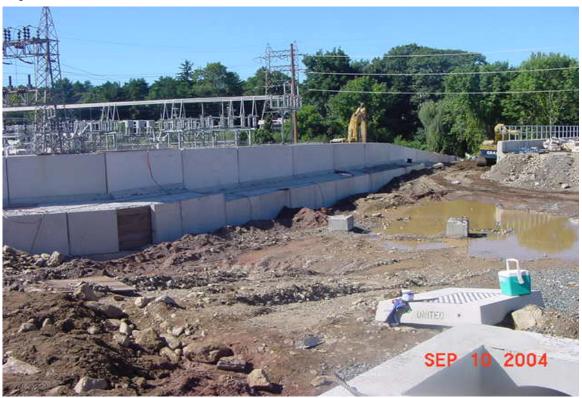
| Areas of Inspection | Observation | Recommended Action |
|---|---|--|
| | - The construction of retaining retaining wall #3 is ongoing and nearing completion. 9/10/04 | - These areas are muddy but well contained at this time. 9/10/04 |

View of the continuing work on retaining wall #3. 9/10/04

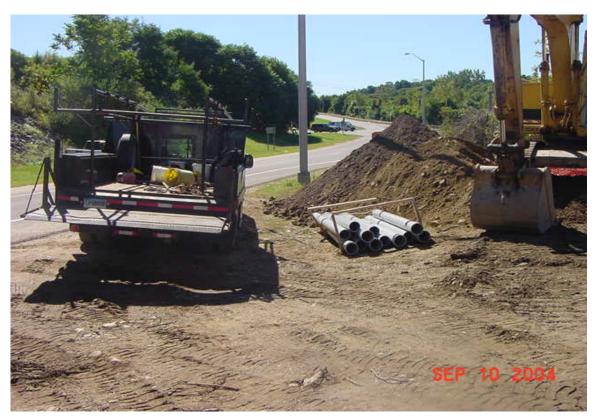
| Areas of Inspection | Observation | Recommended Action |
|---|---|--|
| Foundation construction | - Construction of the conduit<br>bank is ongoing near the<br>control house. Working<br>stockpiles are located up near<br>the Route 7 ramp as a result.<br>9/2-9/10/04 | - The piles have not shown signs of migrating however plastic sheeting or haybales should be used if it becomes necessary. 9/10/04 |

"Working piles" of soil near the Route 7 ramp due to the conduit work in this area. The piles are not migrating into the roadway but plastic sheeting or haybales should be installed if needed. 9/10/04

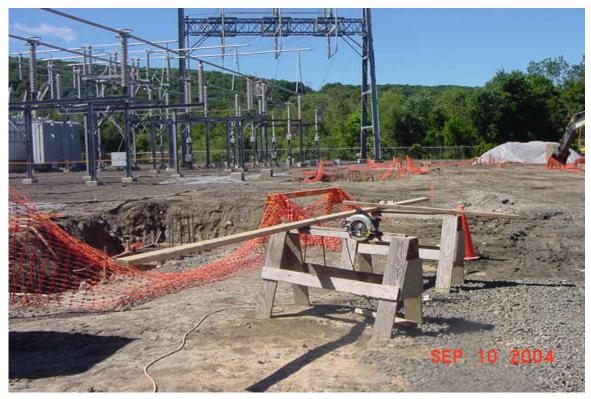
| Areas of Inspection | Observation | Recommended Action |
|---|--|--|
| Foundation construction | -Footing excavation and construction continues in the yard and initial work has begun on the GIS building foundation. 9/10/04 | - The areas are well contained at this time. 9/10/04 |

Plumtree Substation: Over all view of the ongoing footing/excavation work in the yard. 9/10/04

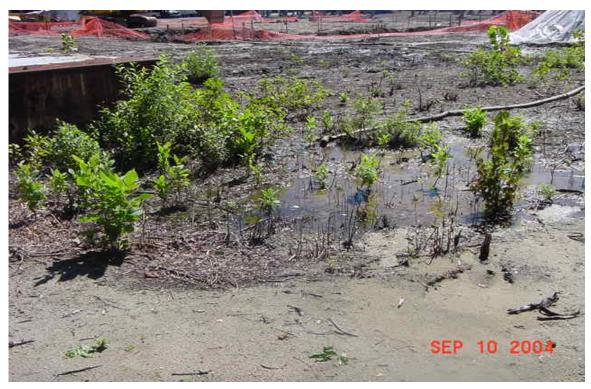
| Areas of Inspection | Observation | Recommended Action |
|---|--|--|
| Dewatering | - Dewatering activities have increased following the storms in order to remove standing water from the excavations. 9/10/04 - The water is being directed to a flat areas within the yard and is being directed away from the stockpiles. 9/10/04 | - The improved perimeter stone barrier is effective at holding water within the fence line and sedimentation has not occurred beyond the edge of the yard. 9/10/04 |

View of one of the dewatering outlets. The recent rain resulted in a lot of standing water/mud on site, but all areas are contained within the yard. 9/10/04

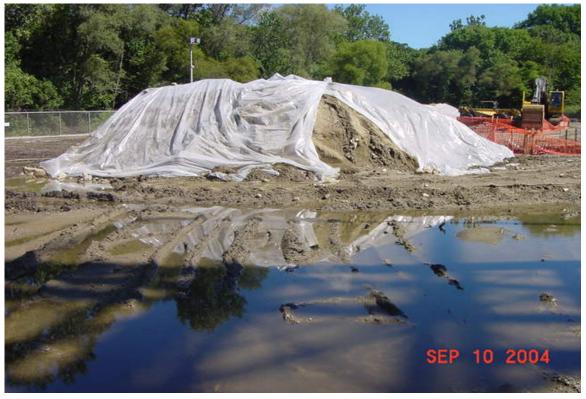
| Areas of Inspection | Observation | Recommended Action |
|---|--|--|
| Erosion and Sediment<br>Controls<br>(includes inspection within 24<br>hours of a storm event) | <ul> <li>There is no silt fence in place at this time, however most stockpiles are covered in plastic and no sedimentation has occurred. 9/10/04</li> <li>Small portions of the plastic cover have blown off the stockpiles due to the storm. 9/10/04</li> <li>The stone perimeter berm is well in place and contains the yard. 9/10/04</li> </ul> | -All areas are well-contained and there is no sedimentation near any off site areas. 9/10/04 - Continue to be proactive in silt fence placement and maintenance. The area noted will be repaired. 9/10/04 |

Some of the plastic covering on the stockpile had blown off due to the wind and will be replaced. The entire area remains contained within the yard. 9/10/04
